**Location:** P&H MinePro Services Australasia  
 SHE38 – BMA Saraji

**Incident Date:** 10/02/2011  
**Safety Alert No:** SA10044

## EWP – INTERNAL RUST IN BOOM SECTION

#### Model: JLG LIFT 600AJ

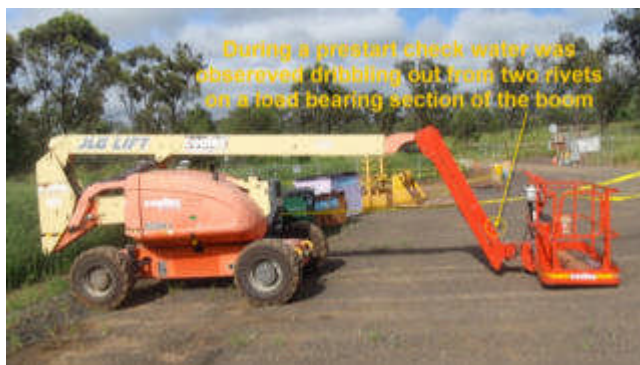
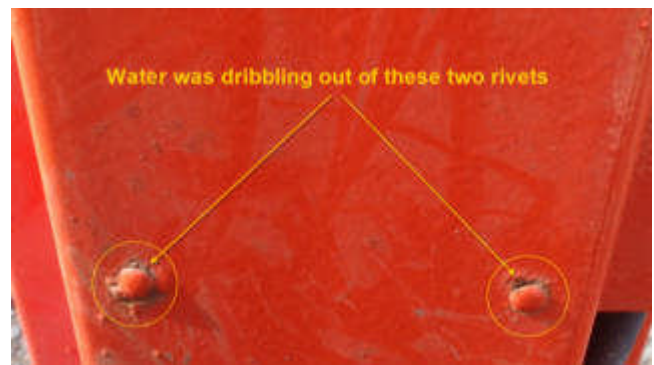
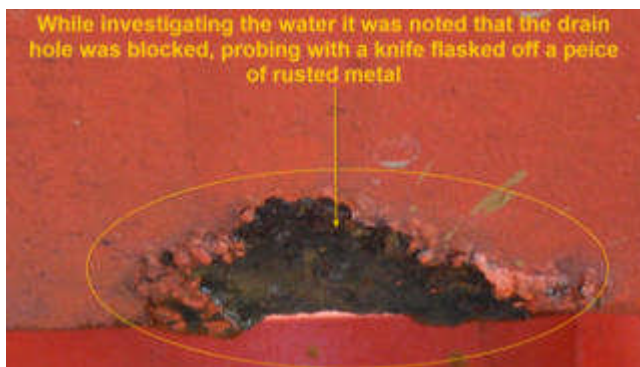
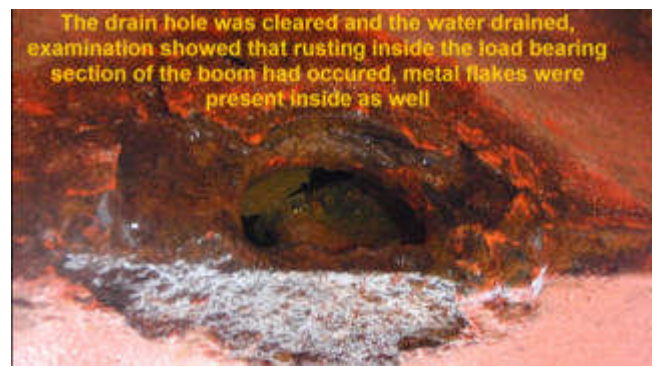
During a prestart inspection it was noticed that water was leaking out of rivets on the top boom section near the basket, upon closer inspection was found that a drain hole was block and approximately 300mm of water was retained inside the boom section.

The drain hole was unblocked and the water drained, an area of rusted metal flaked off externally near the drain hole further investigation revealed that the hole itself was out of shape due to rust and flakes of rusted metal could be seen inside the boom section.

Checking drain holes in boom sections not documented in manufacturers daily prestart check lists.

- Parked up the EWP and tagged out of service.
- Contacted the hirer who sent out a service rep to inspect the unit which was changed out for another EWP.
- Gave contact details to the service rep for feed back from the hirer regarding checks on other equipment currently in use and updating the daily prestart checklist in the hand book supplied to include drain holes.
- Raised a BMA Hazard ID for entry into BMA Saraji's first priority system.
- Included into SHE38 prestart meetings to ensure that drain holes become part of the EWP prestart checks.
