INITIAL INCIDENT ANNOUNCEMENT

Business Unit:
 Project/Operation Name: Team: **SURF**
 Incident Report No: **48**
 Incident classification: **DAFWC**

Location of incident: **Sonamet yard 1, Spools fabrication area.**

Date of incident: **Monday 2nd July 2007**

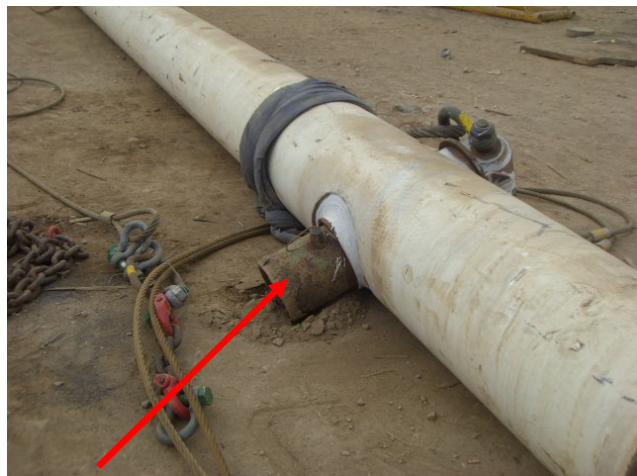
The crane driver lowered the spreader bar to the ground, on this occasion the Spreader bar remained standing on the 240mm lift pins which acted as legs. Normally the Spreader bar would have been rested on its side. The Rigger approached the free standing Spreader bar and proceeded to unhook the rigging from the crane hook. Without warning the Spreader bar fell towards the Rigger trapping his left foot on impact to the ground.

Spreader beam after fall

Failure to lay down load (Spreader Bar) in a stable and safe manor.

The Spreader bar was placed in quarantine until investigation completed.

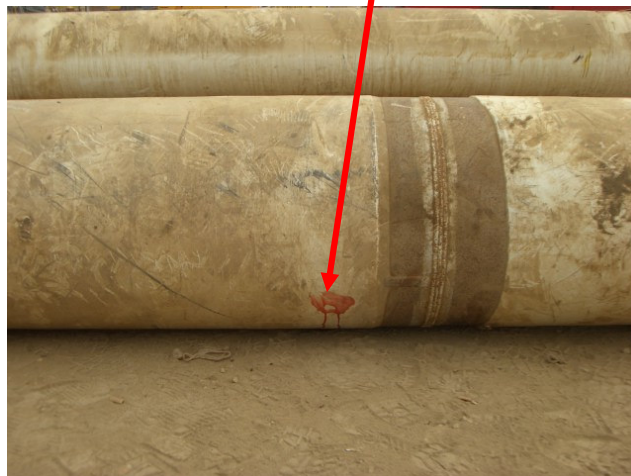
240mm lift pins

Point where spreader beam crushed persons foot

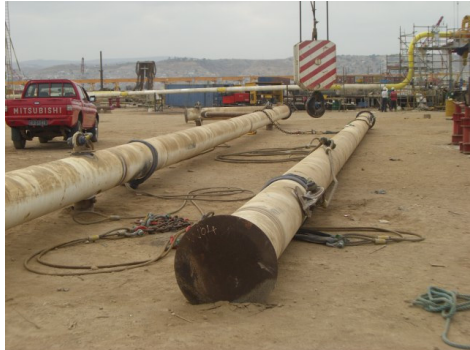
Spreader Beams

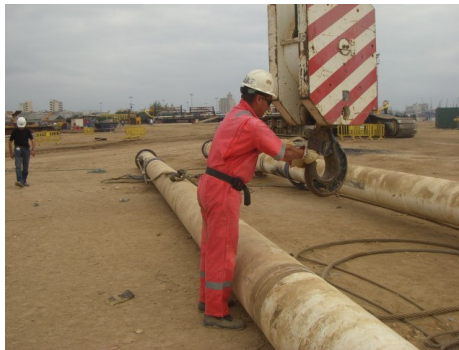
Failure to identify unstable load as a hazard before placing body near load.

Position of Rigger
(re-enactment with beam after fall)

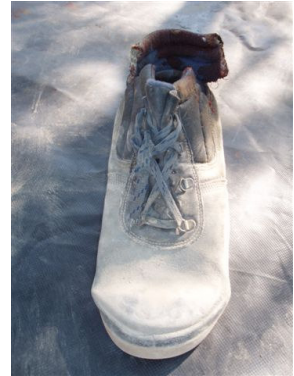
The Rigger sustained serious injuries to his left foot. Later the same day he underwent surgery to amputate his foot at the ankle as his injuries were so severe it could not be saved.

Boot from injured person
