Visit to Site

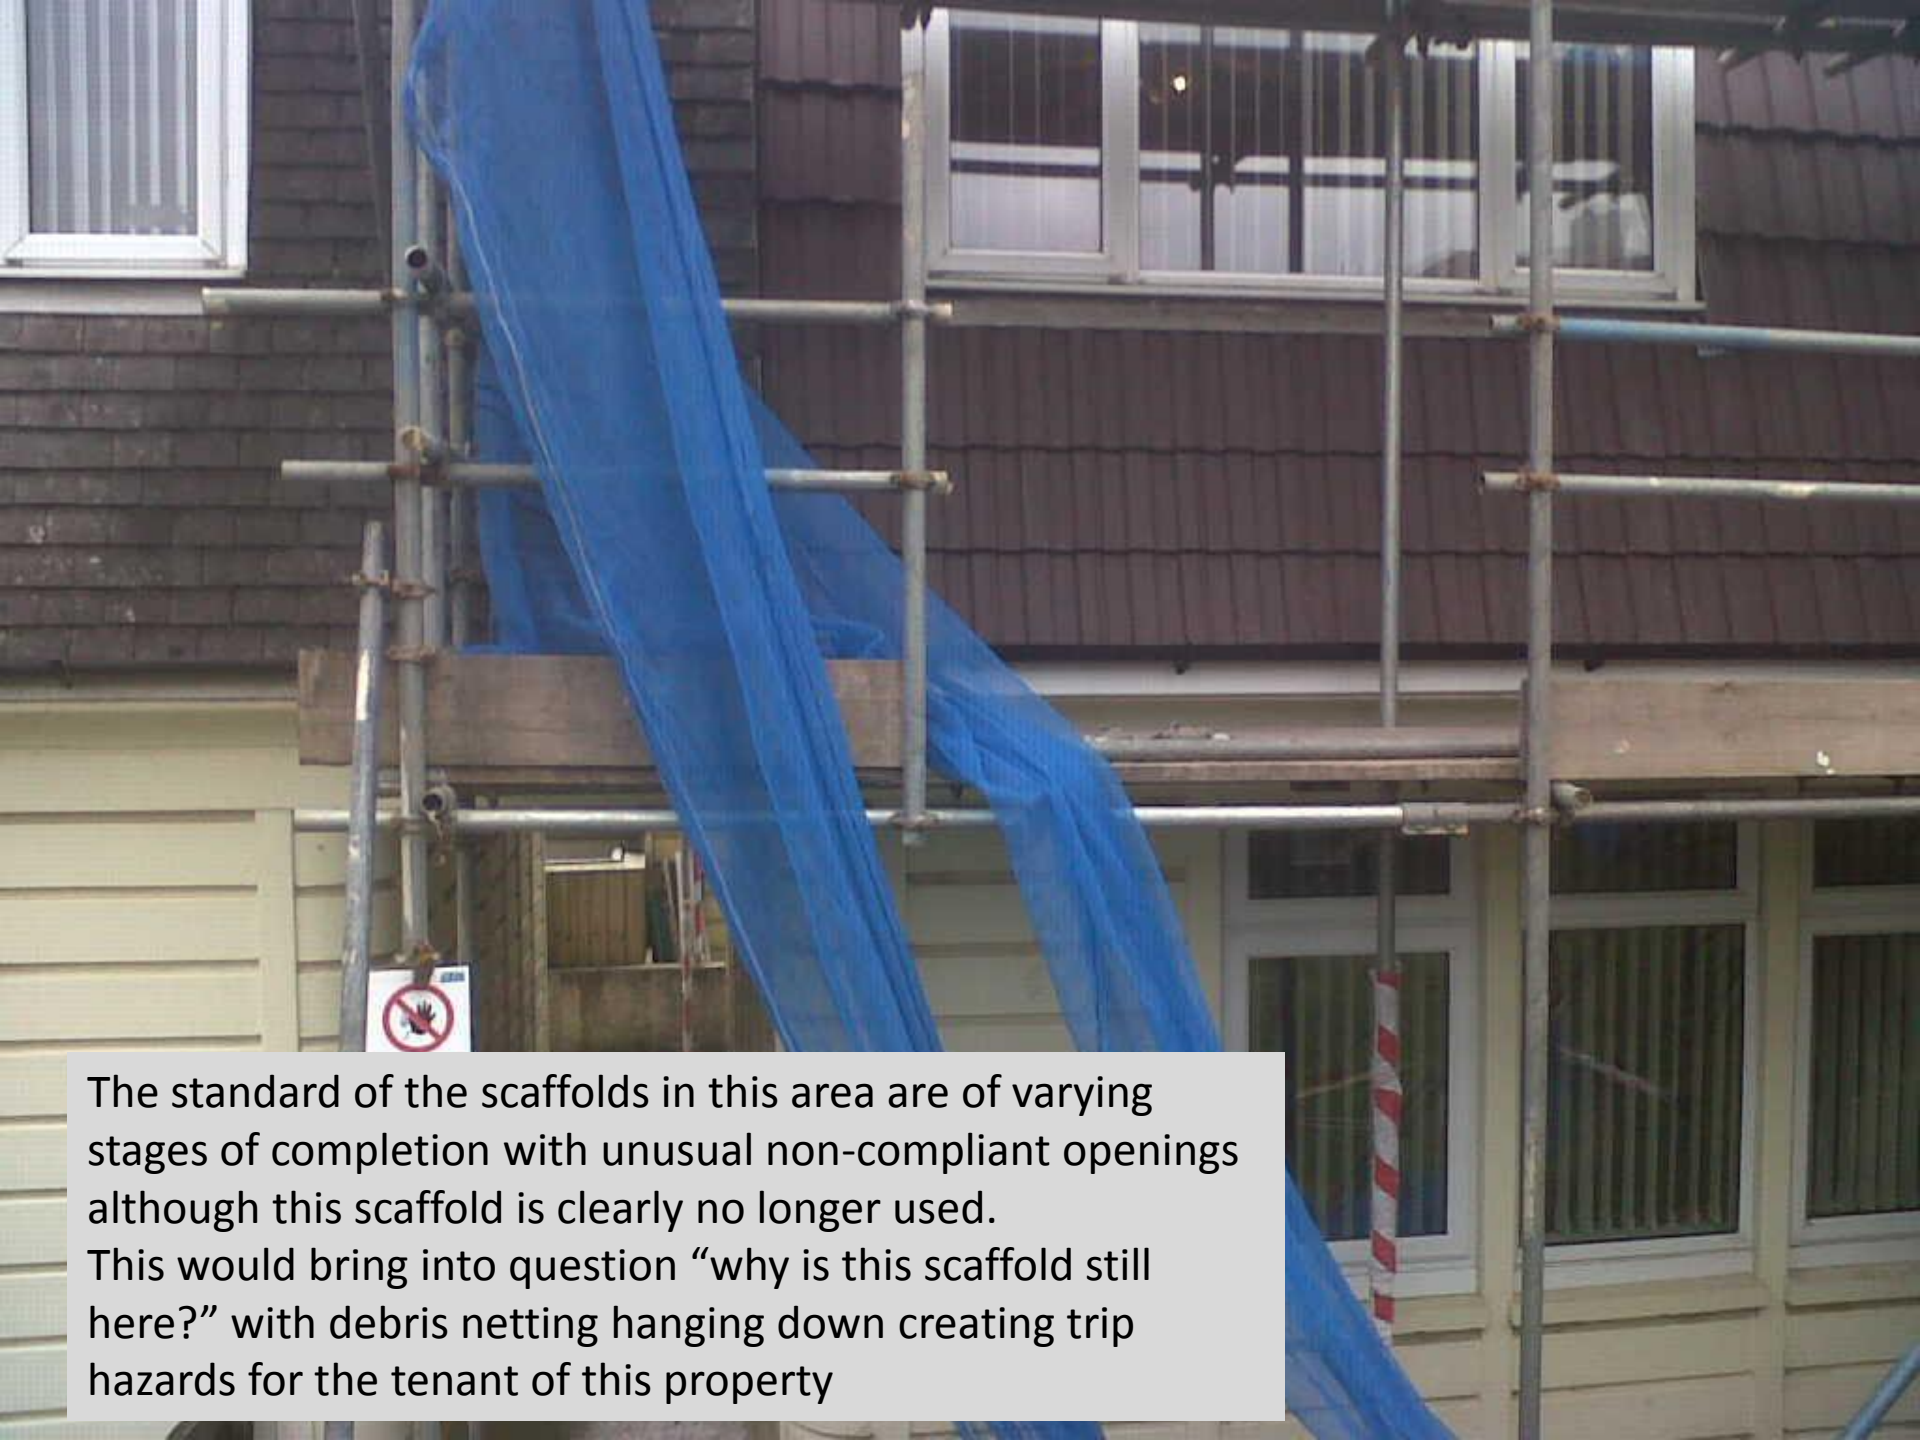
The standard of the scaffolds in this area are of varying stages of completion with unusual non-compliant openings although this scaffold is clearly no longer used. This would bring into question “why is this scaffold still here?” with debris netting hanging down creating trip hazards for the tenant of this property

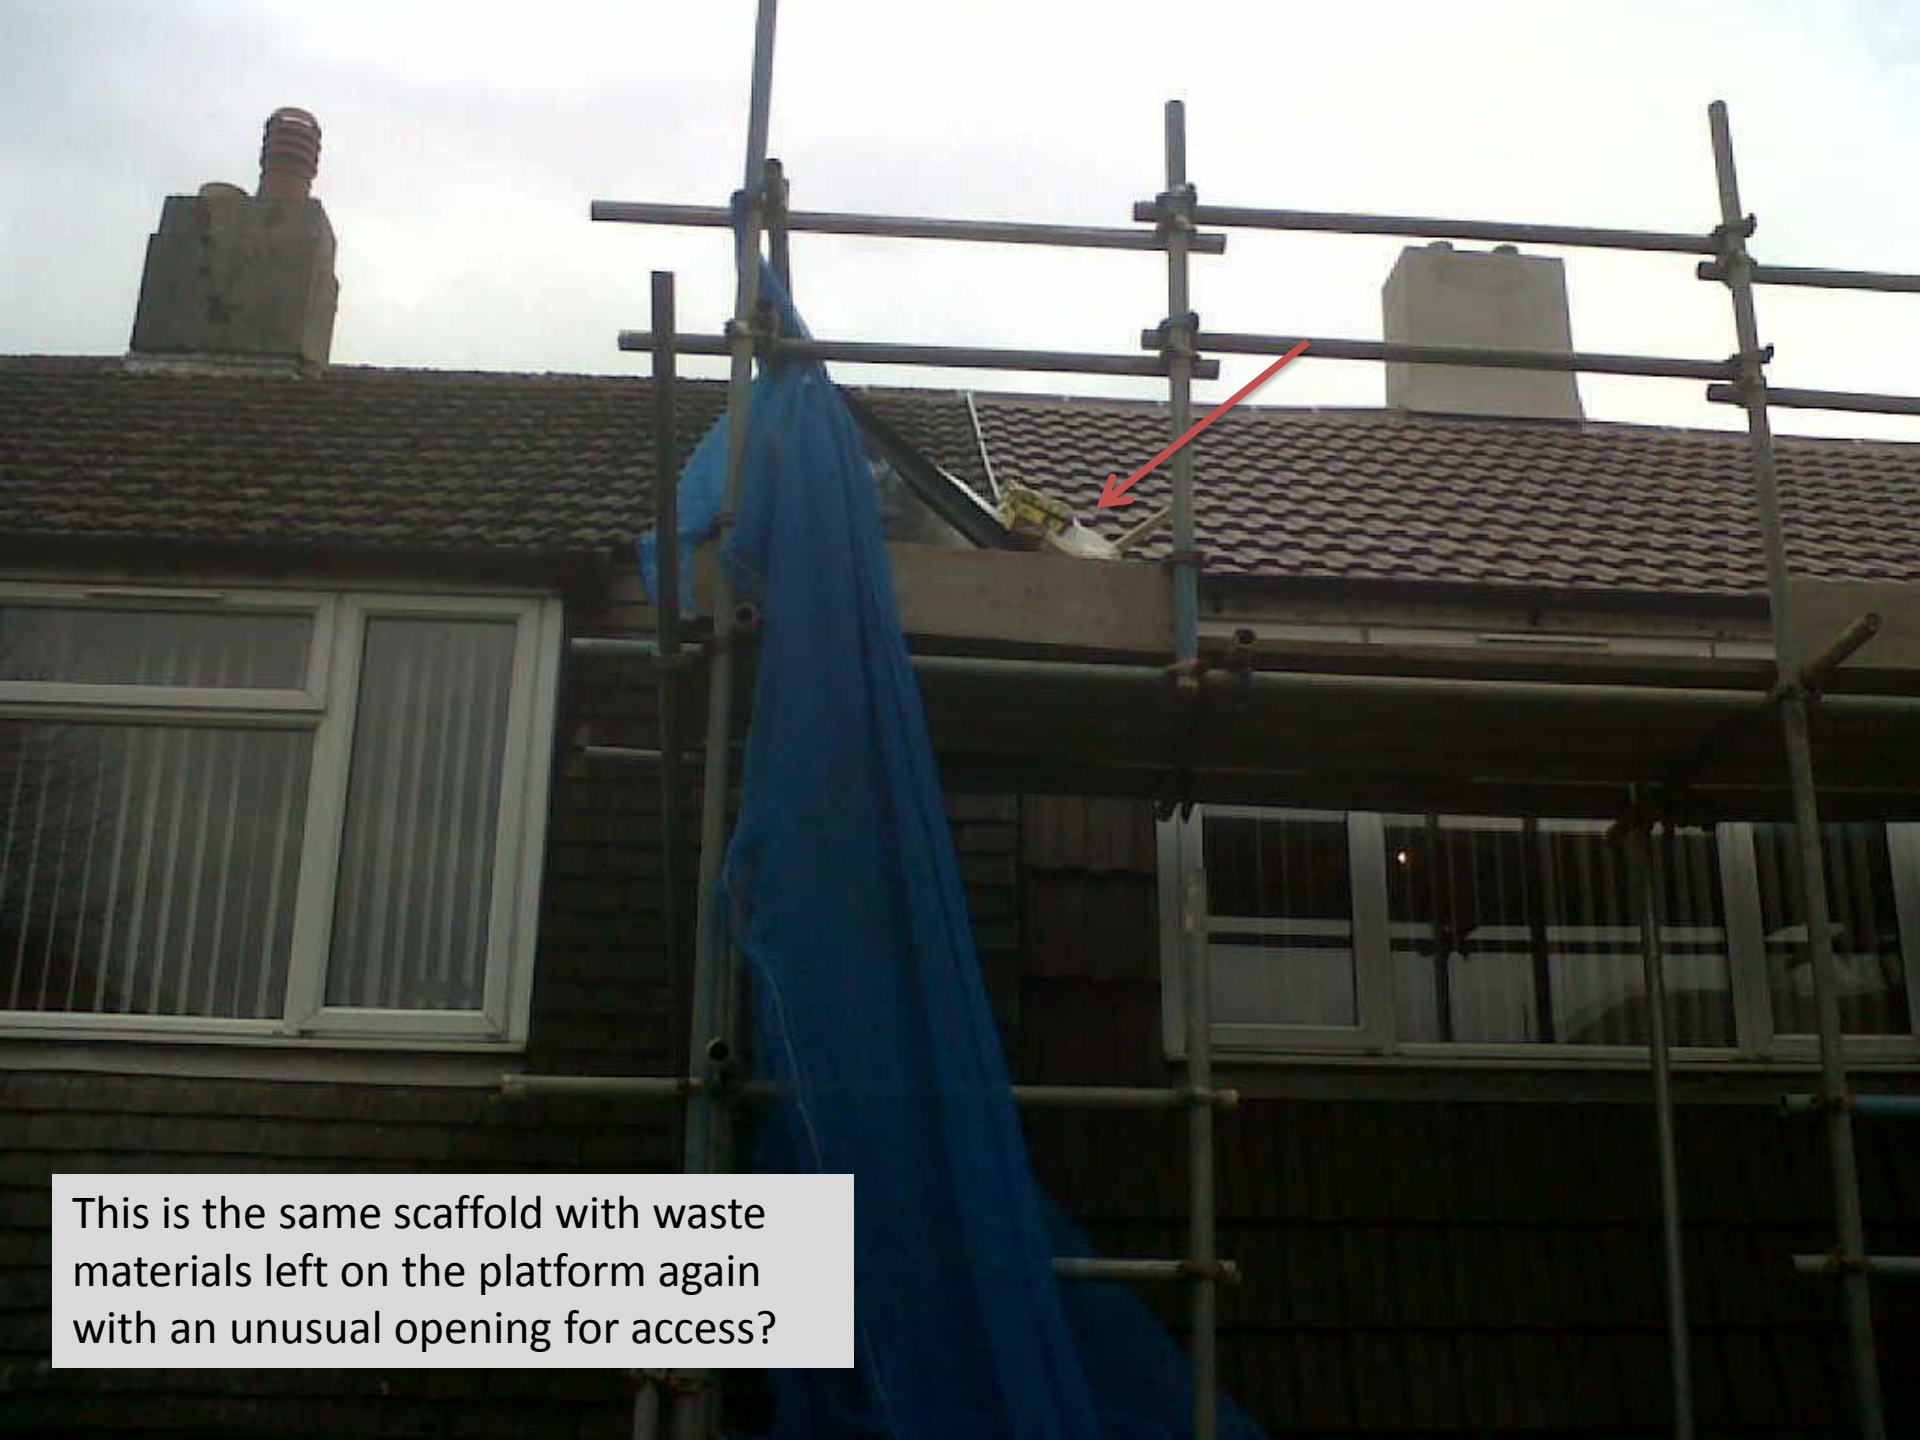
This is the same scaffold with waste materials left on the platform again with an unusual opening for access?

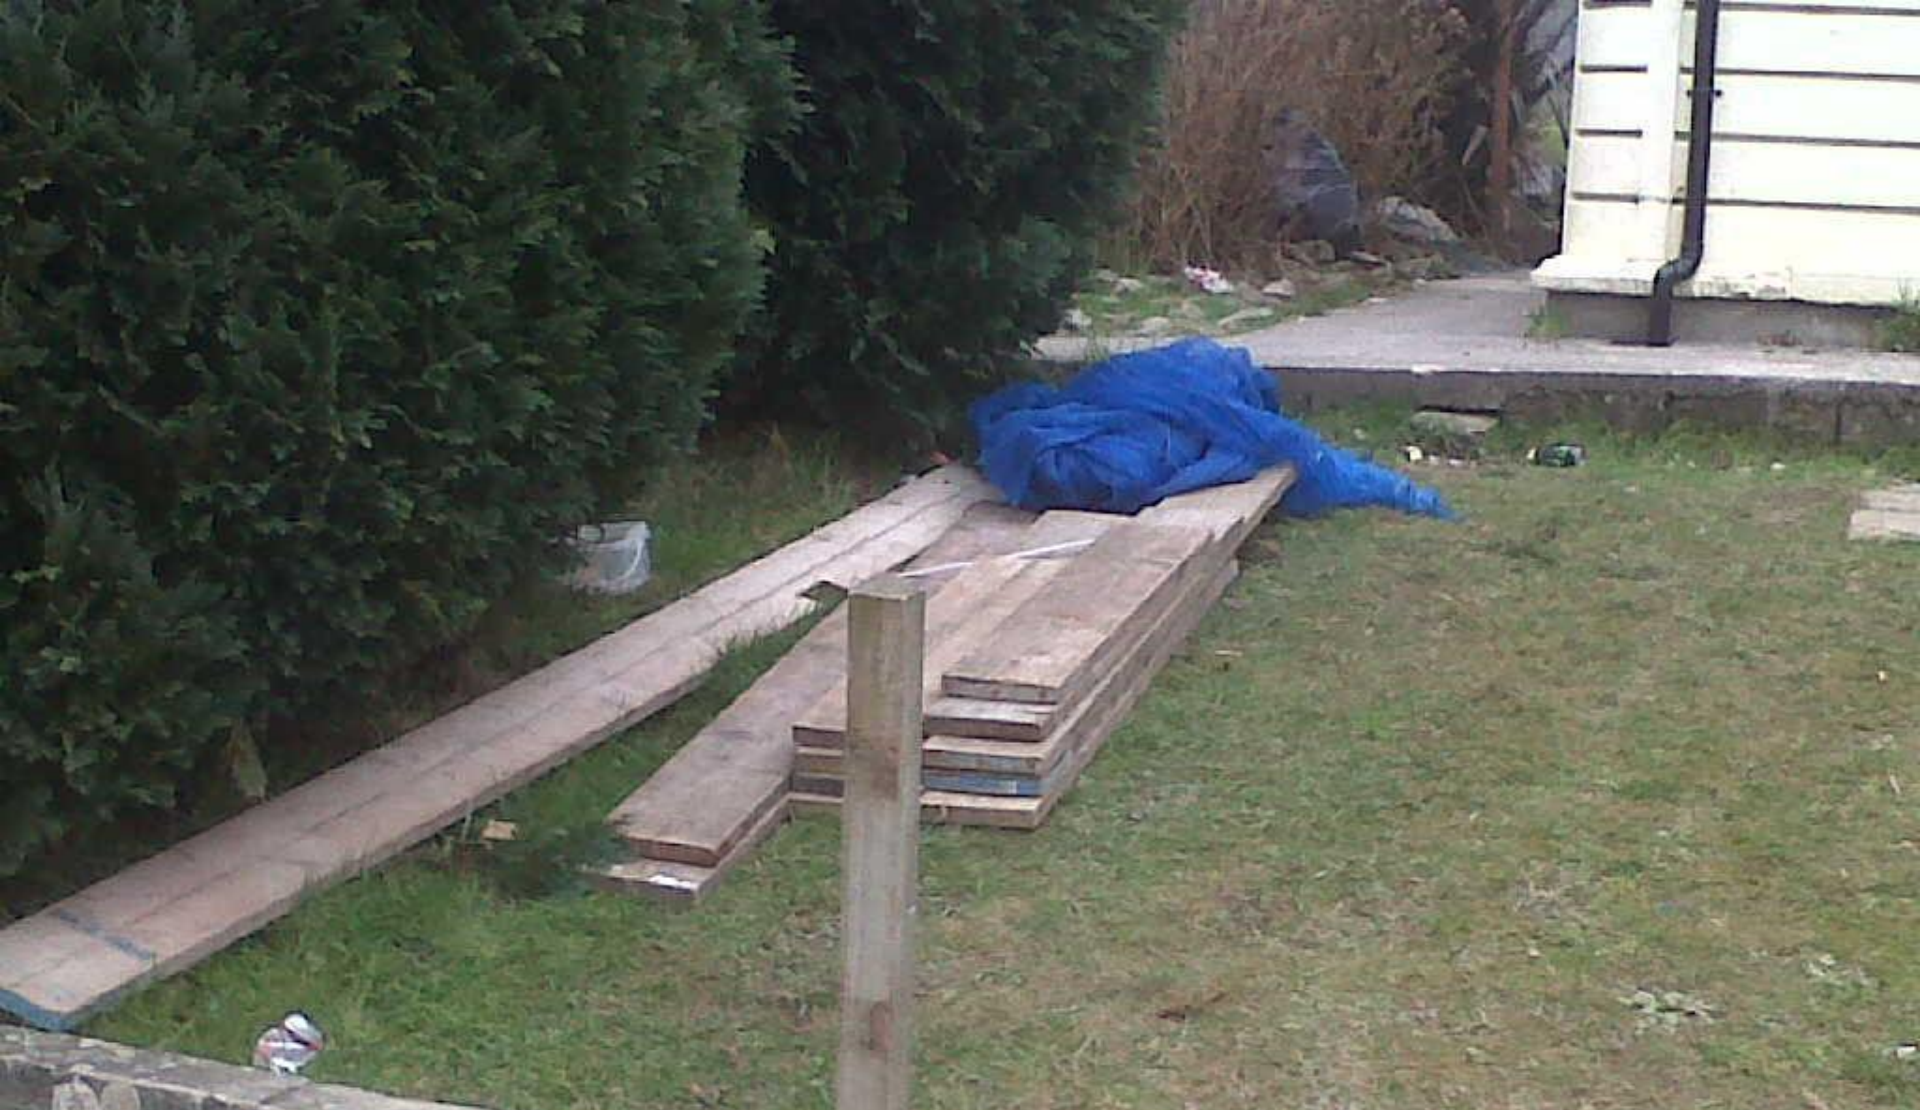
This property has been completed with the scaffold removed although the front garden is being used for storage of materials by the contractors – it was noted young children coming and going from this property.

As you can see from the photo there has been considerable damage to the grass verges all along this street even though the bollards have been installed to prevent this.

The contractor did say that it was not only his lorries that had done the damage but other lorries from other contractors also used the grass verges to park on.

Contractors have confirmed they will repair the verges upon completion of works.

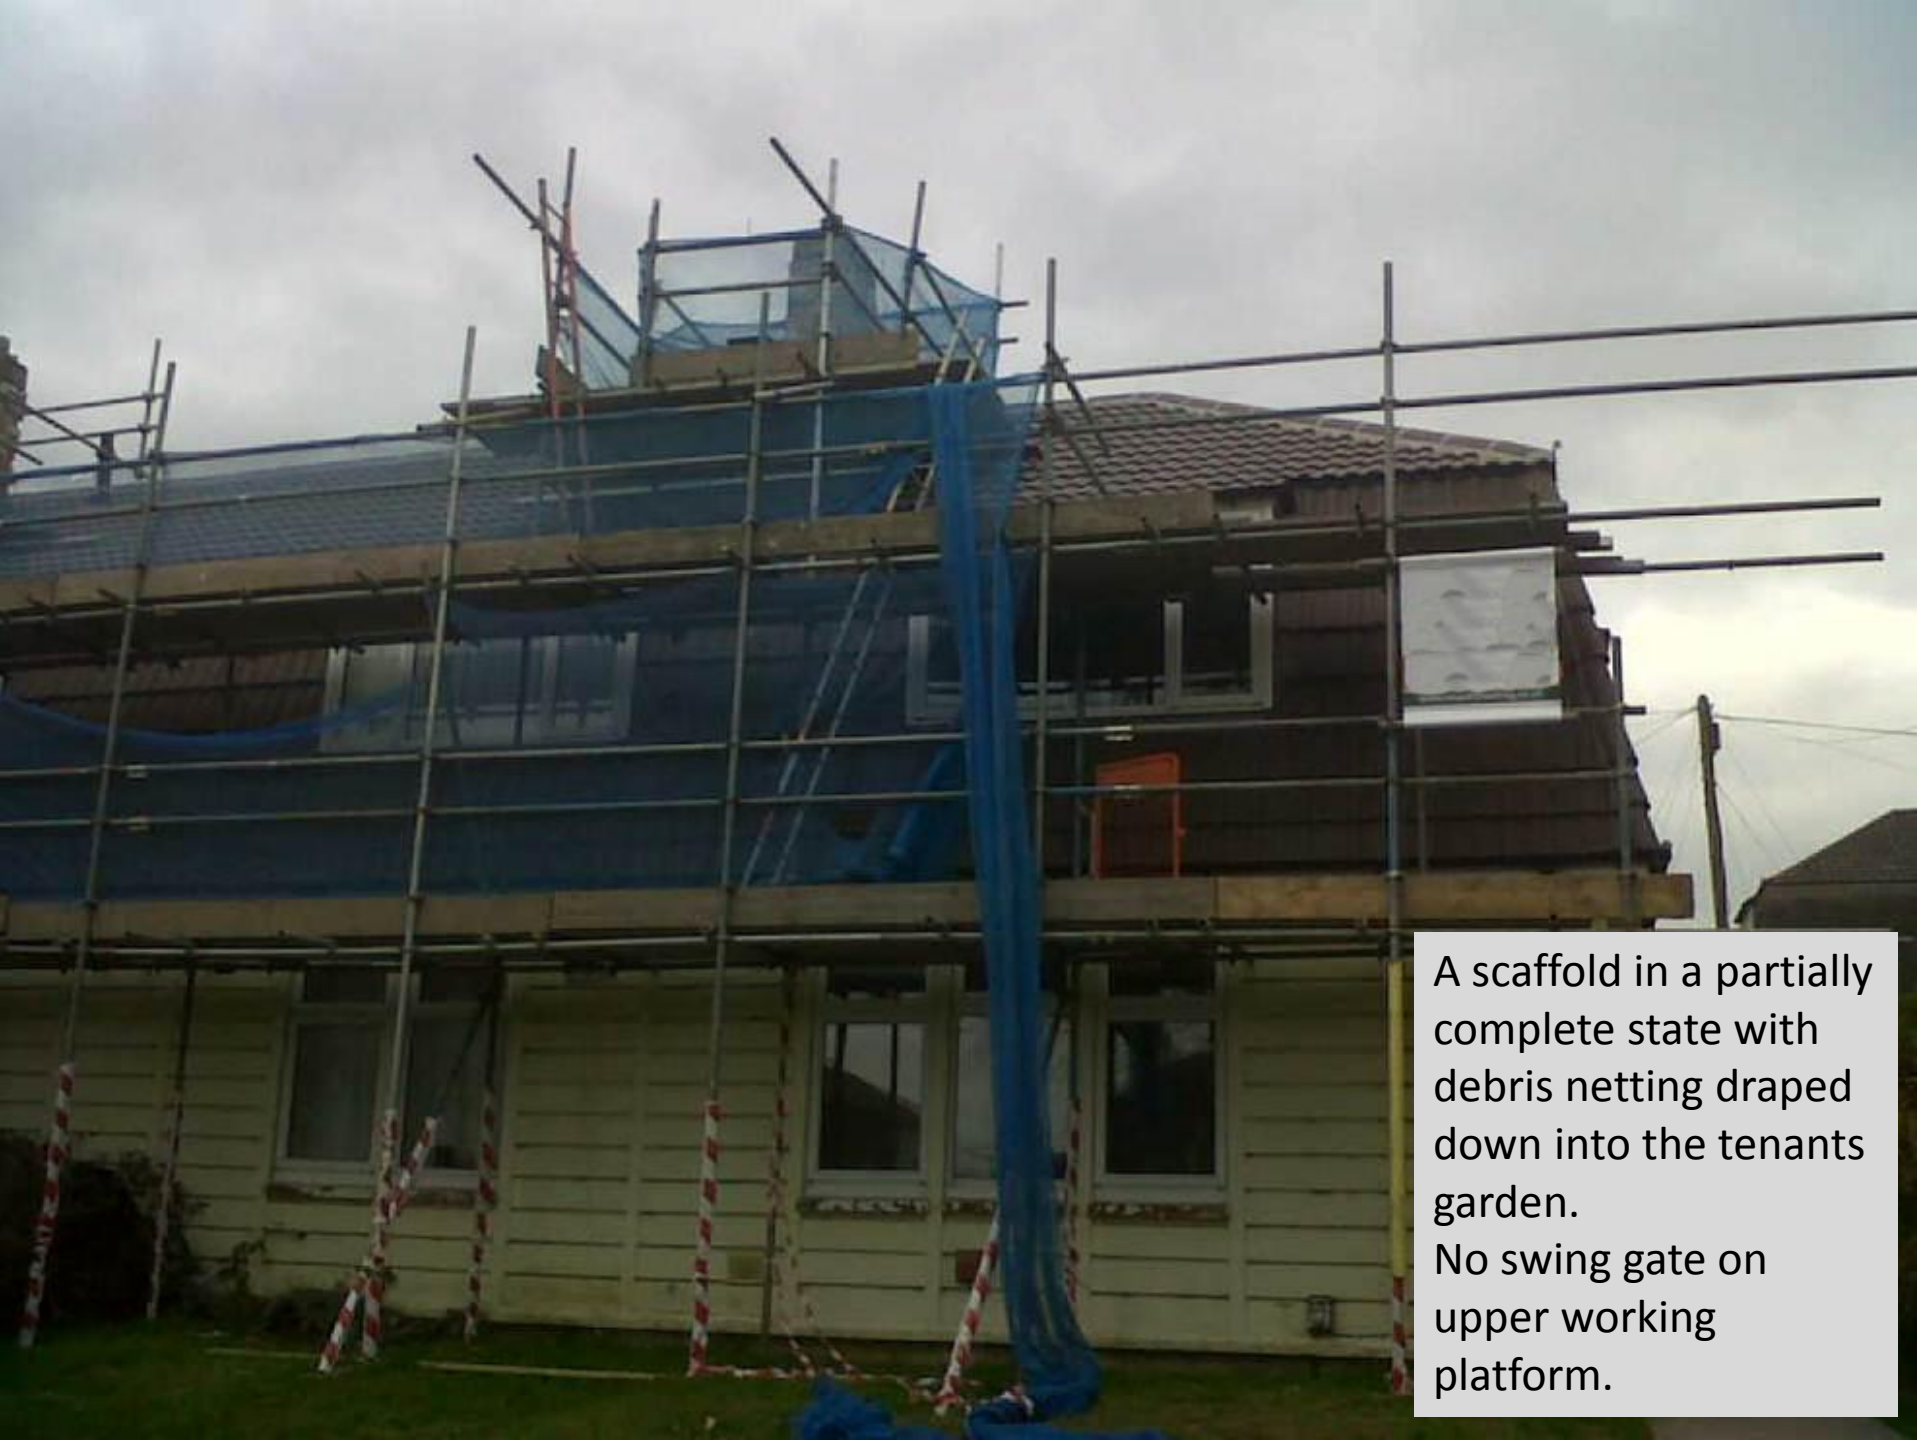
A scaffold in a partially complete state with debris netting draped down into the tenants garden.
No swing gate on upper working platform.

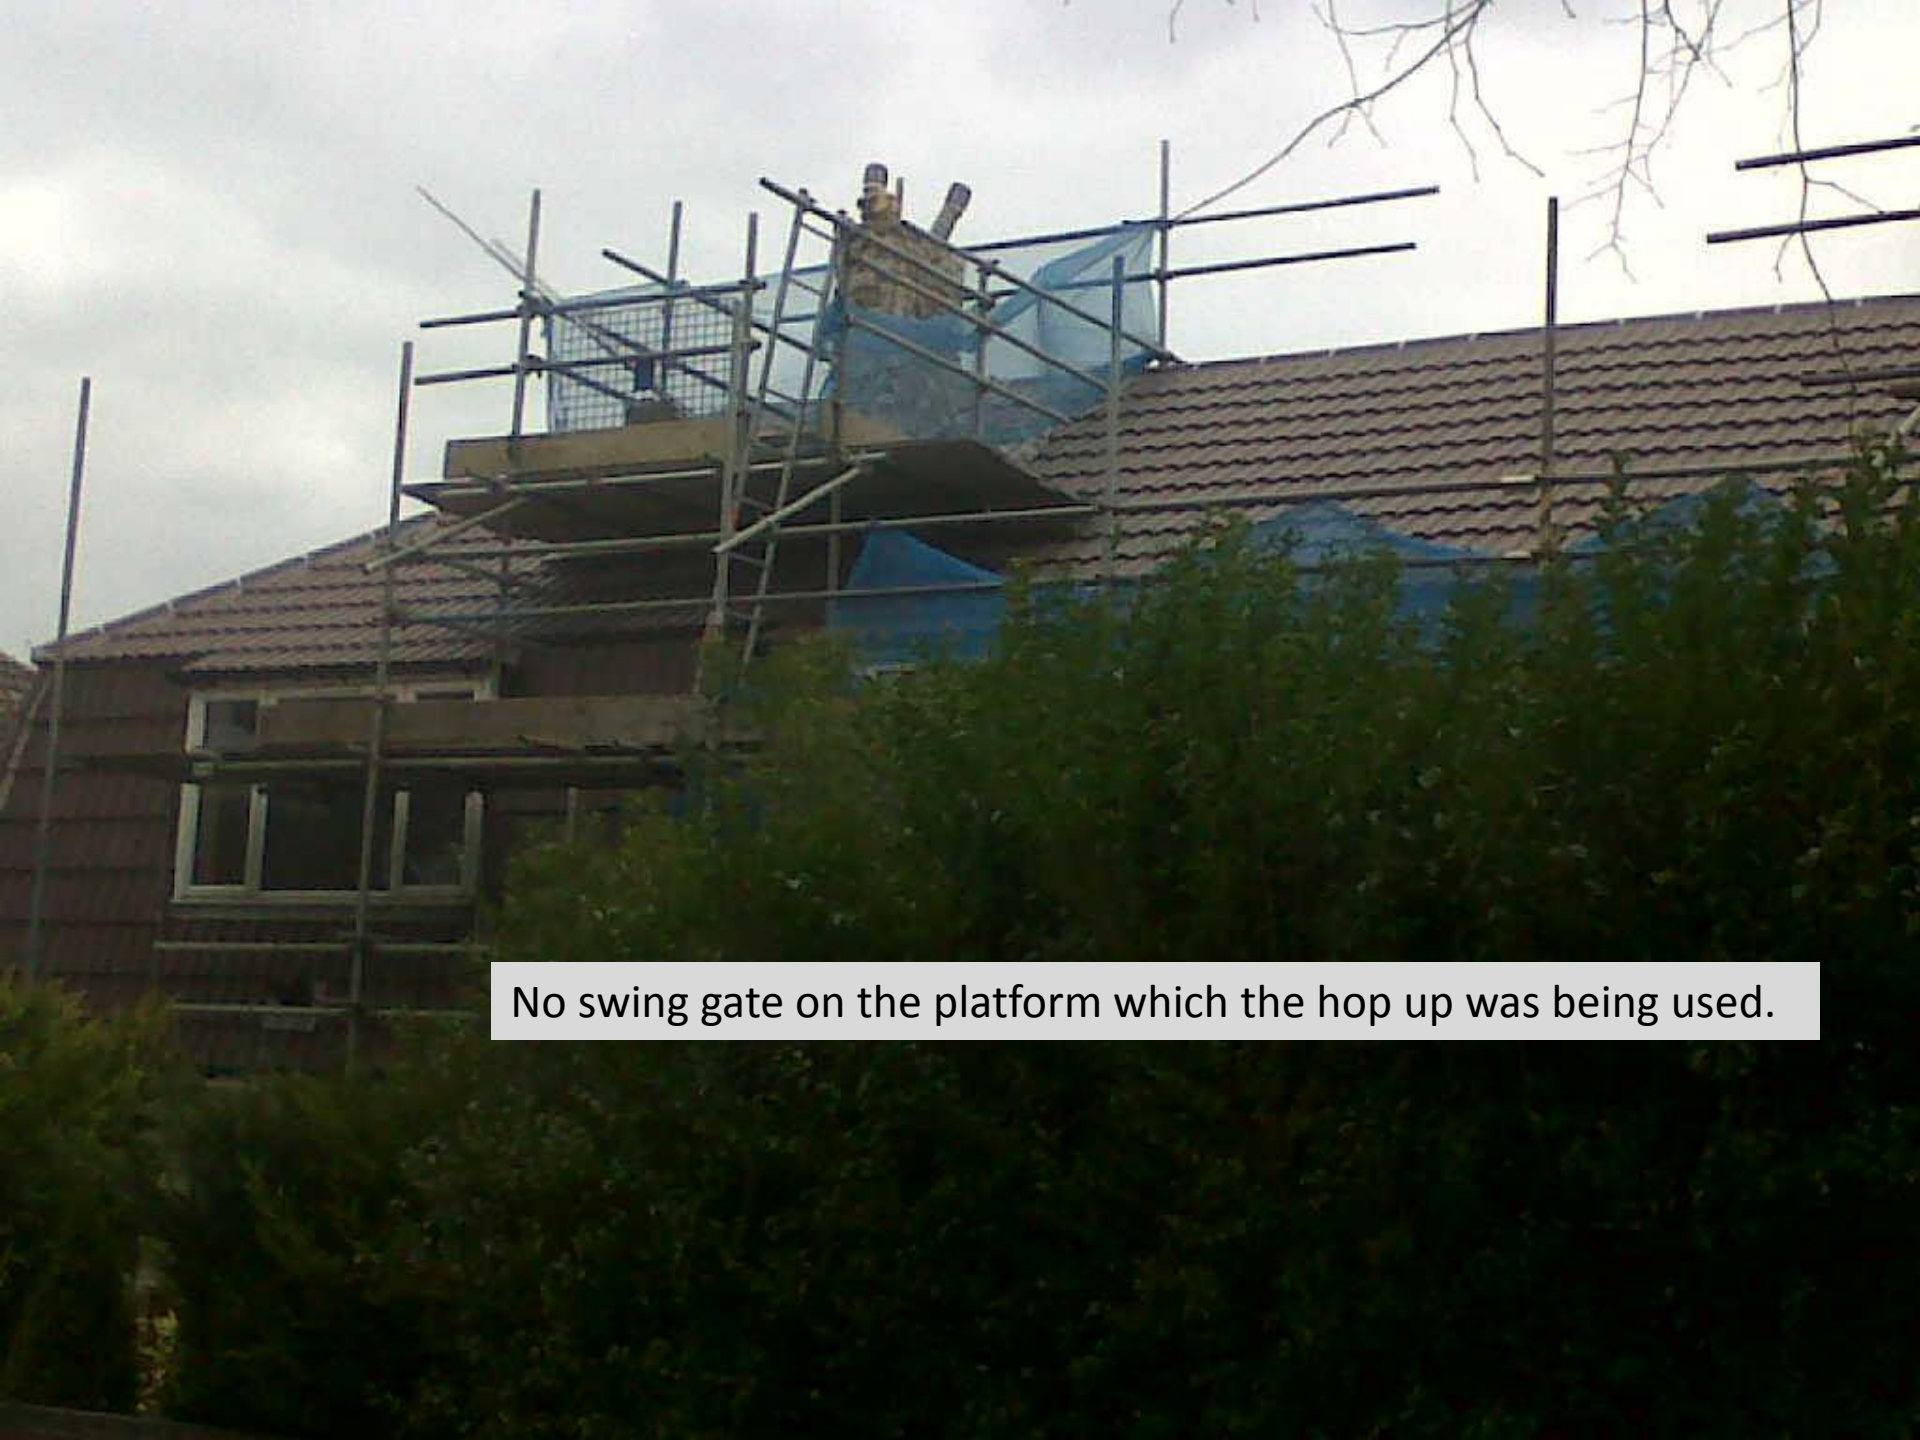
No swing gate on the platform which the hop up was being used.

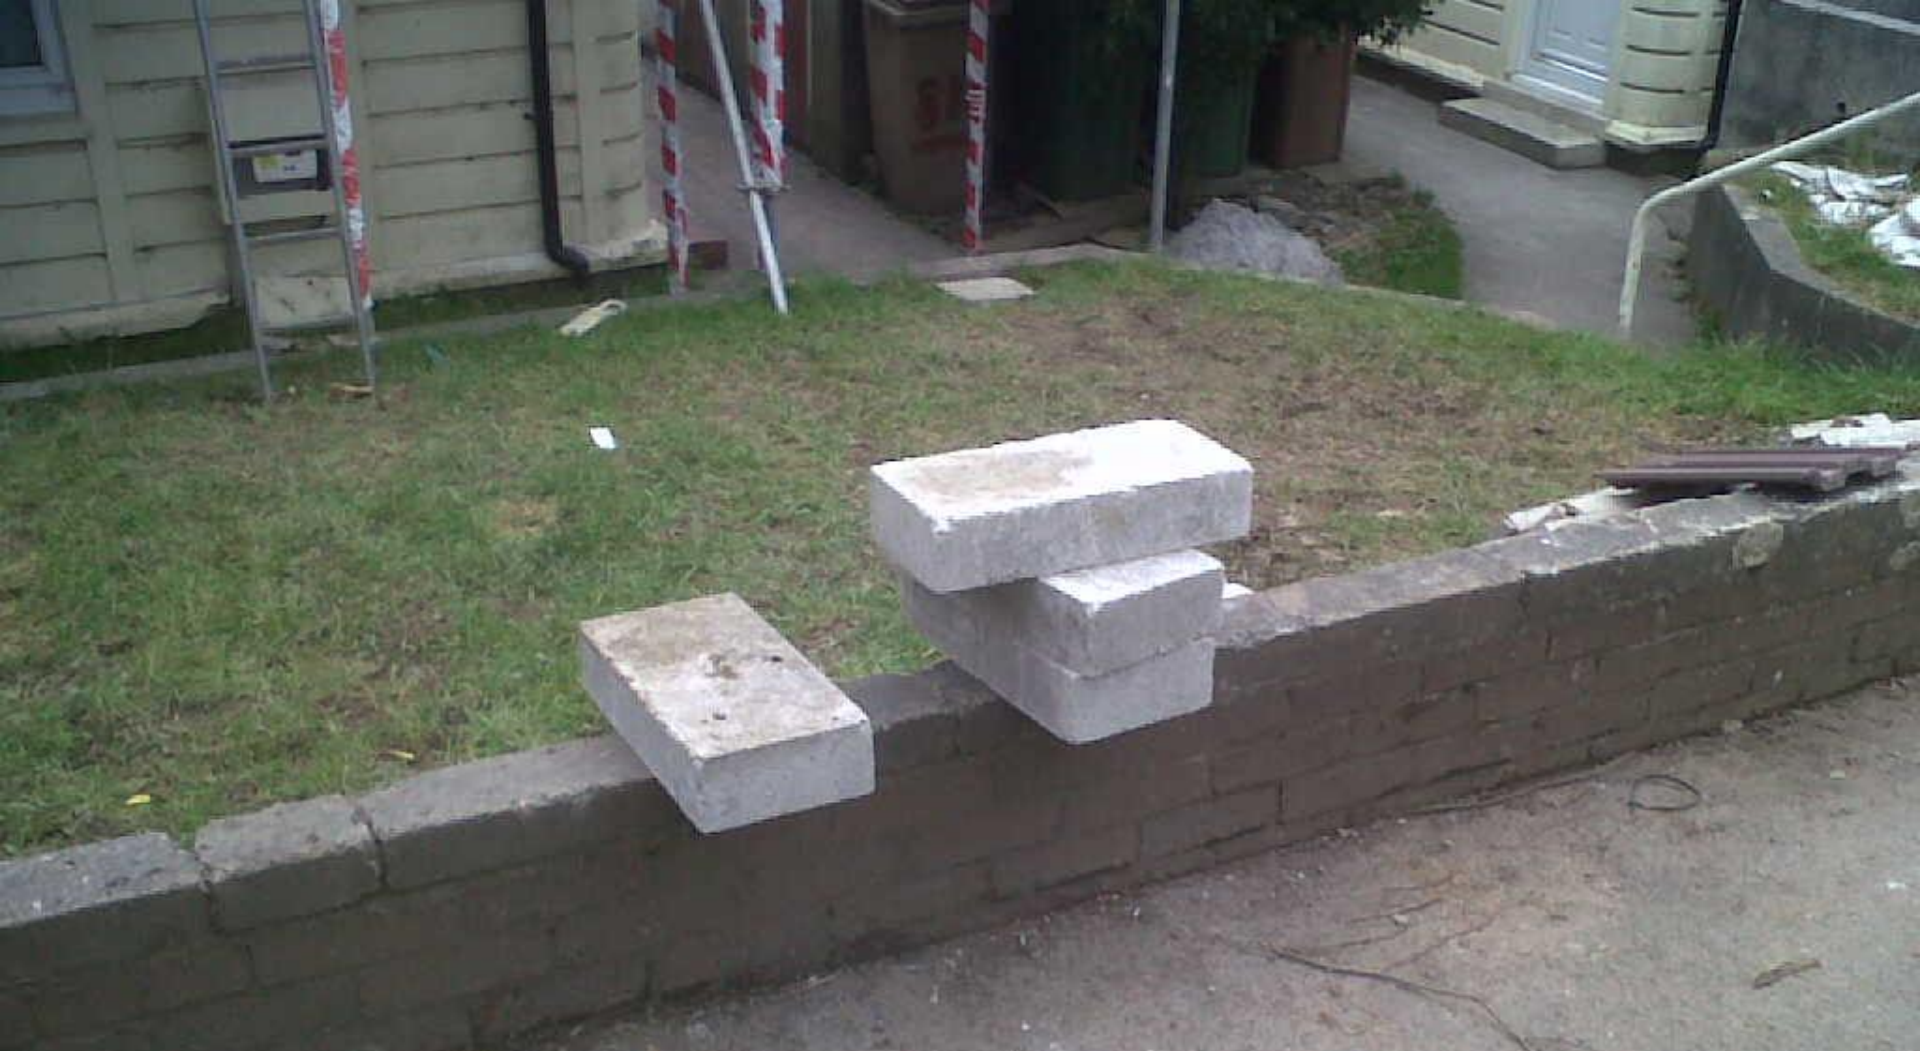
The site staff removed these blocks upon request.

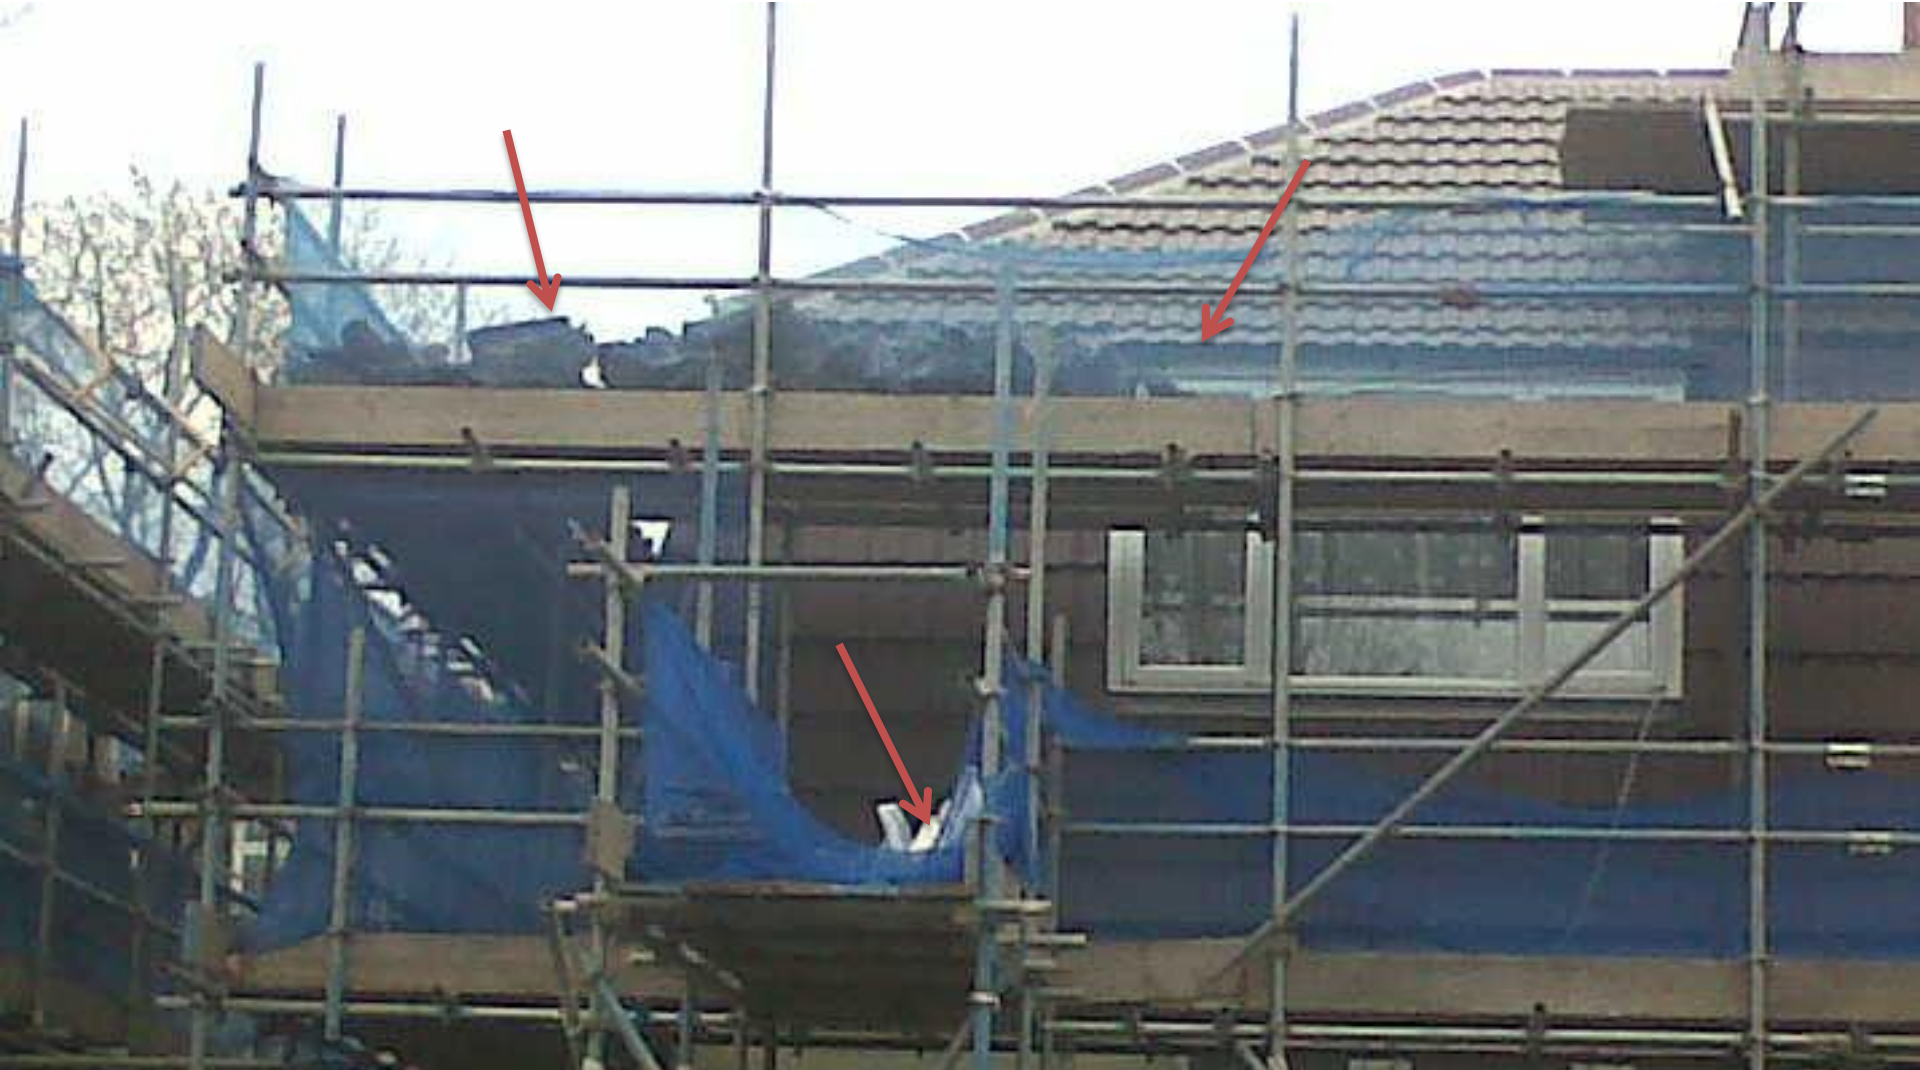
This scaffold was no longer being used although the working platform was full of waste material.

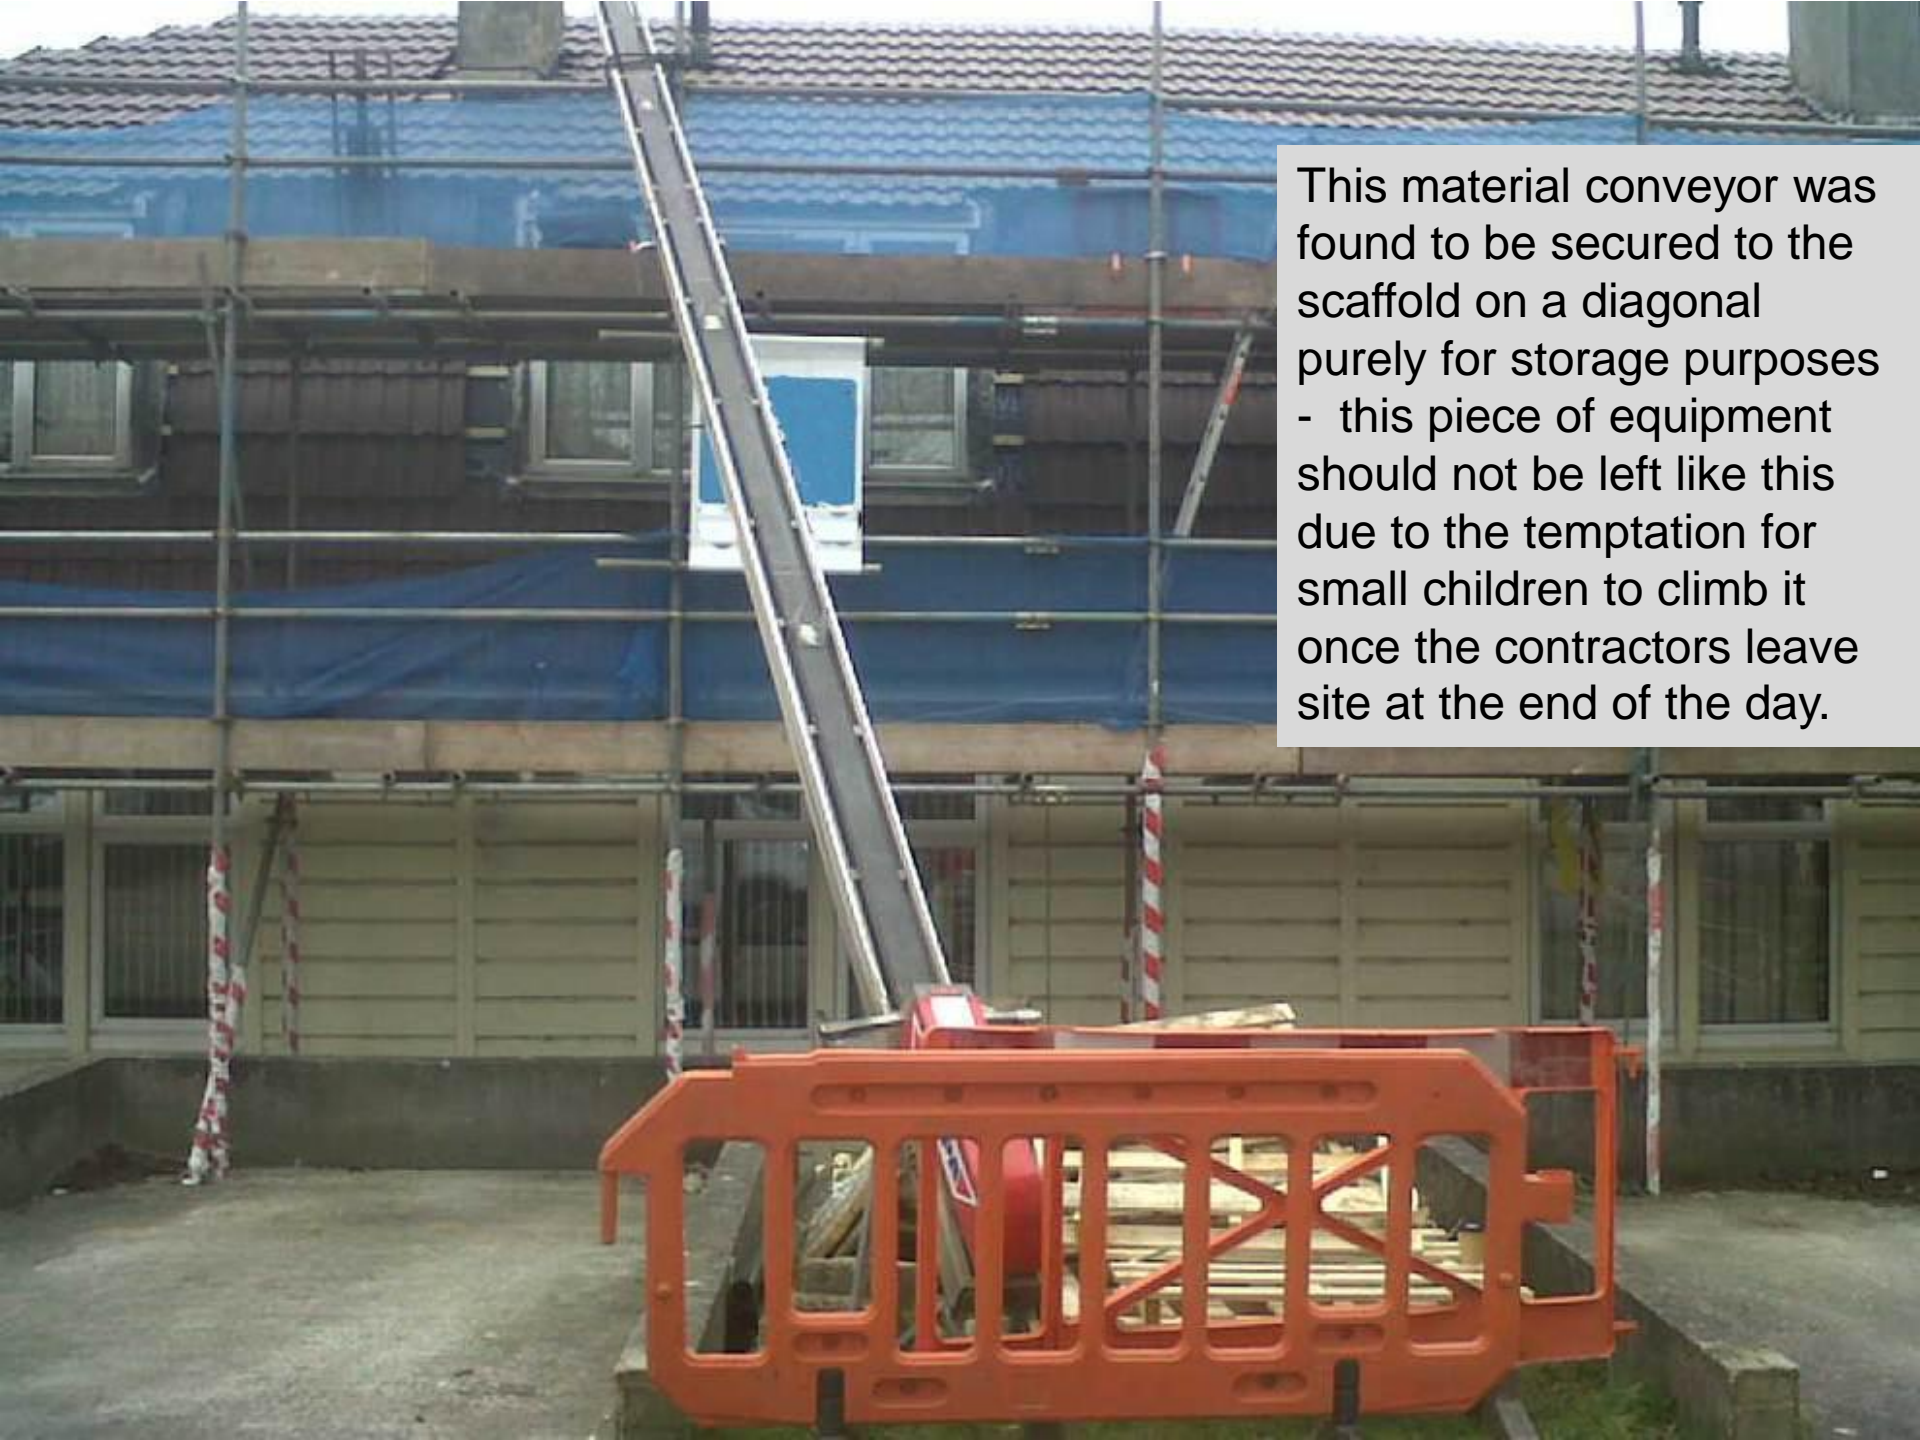
This material conveyor was found to be secured to the scaffold on a diagonal purely for storage purposes - this piece of equipment should not be left like this due to the temptation for small children to climb it once the contractors leave site at the end of the day.

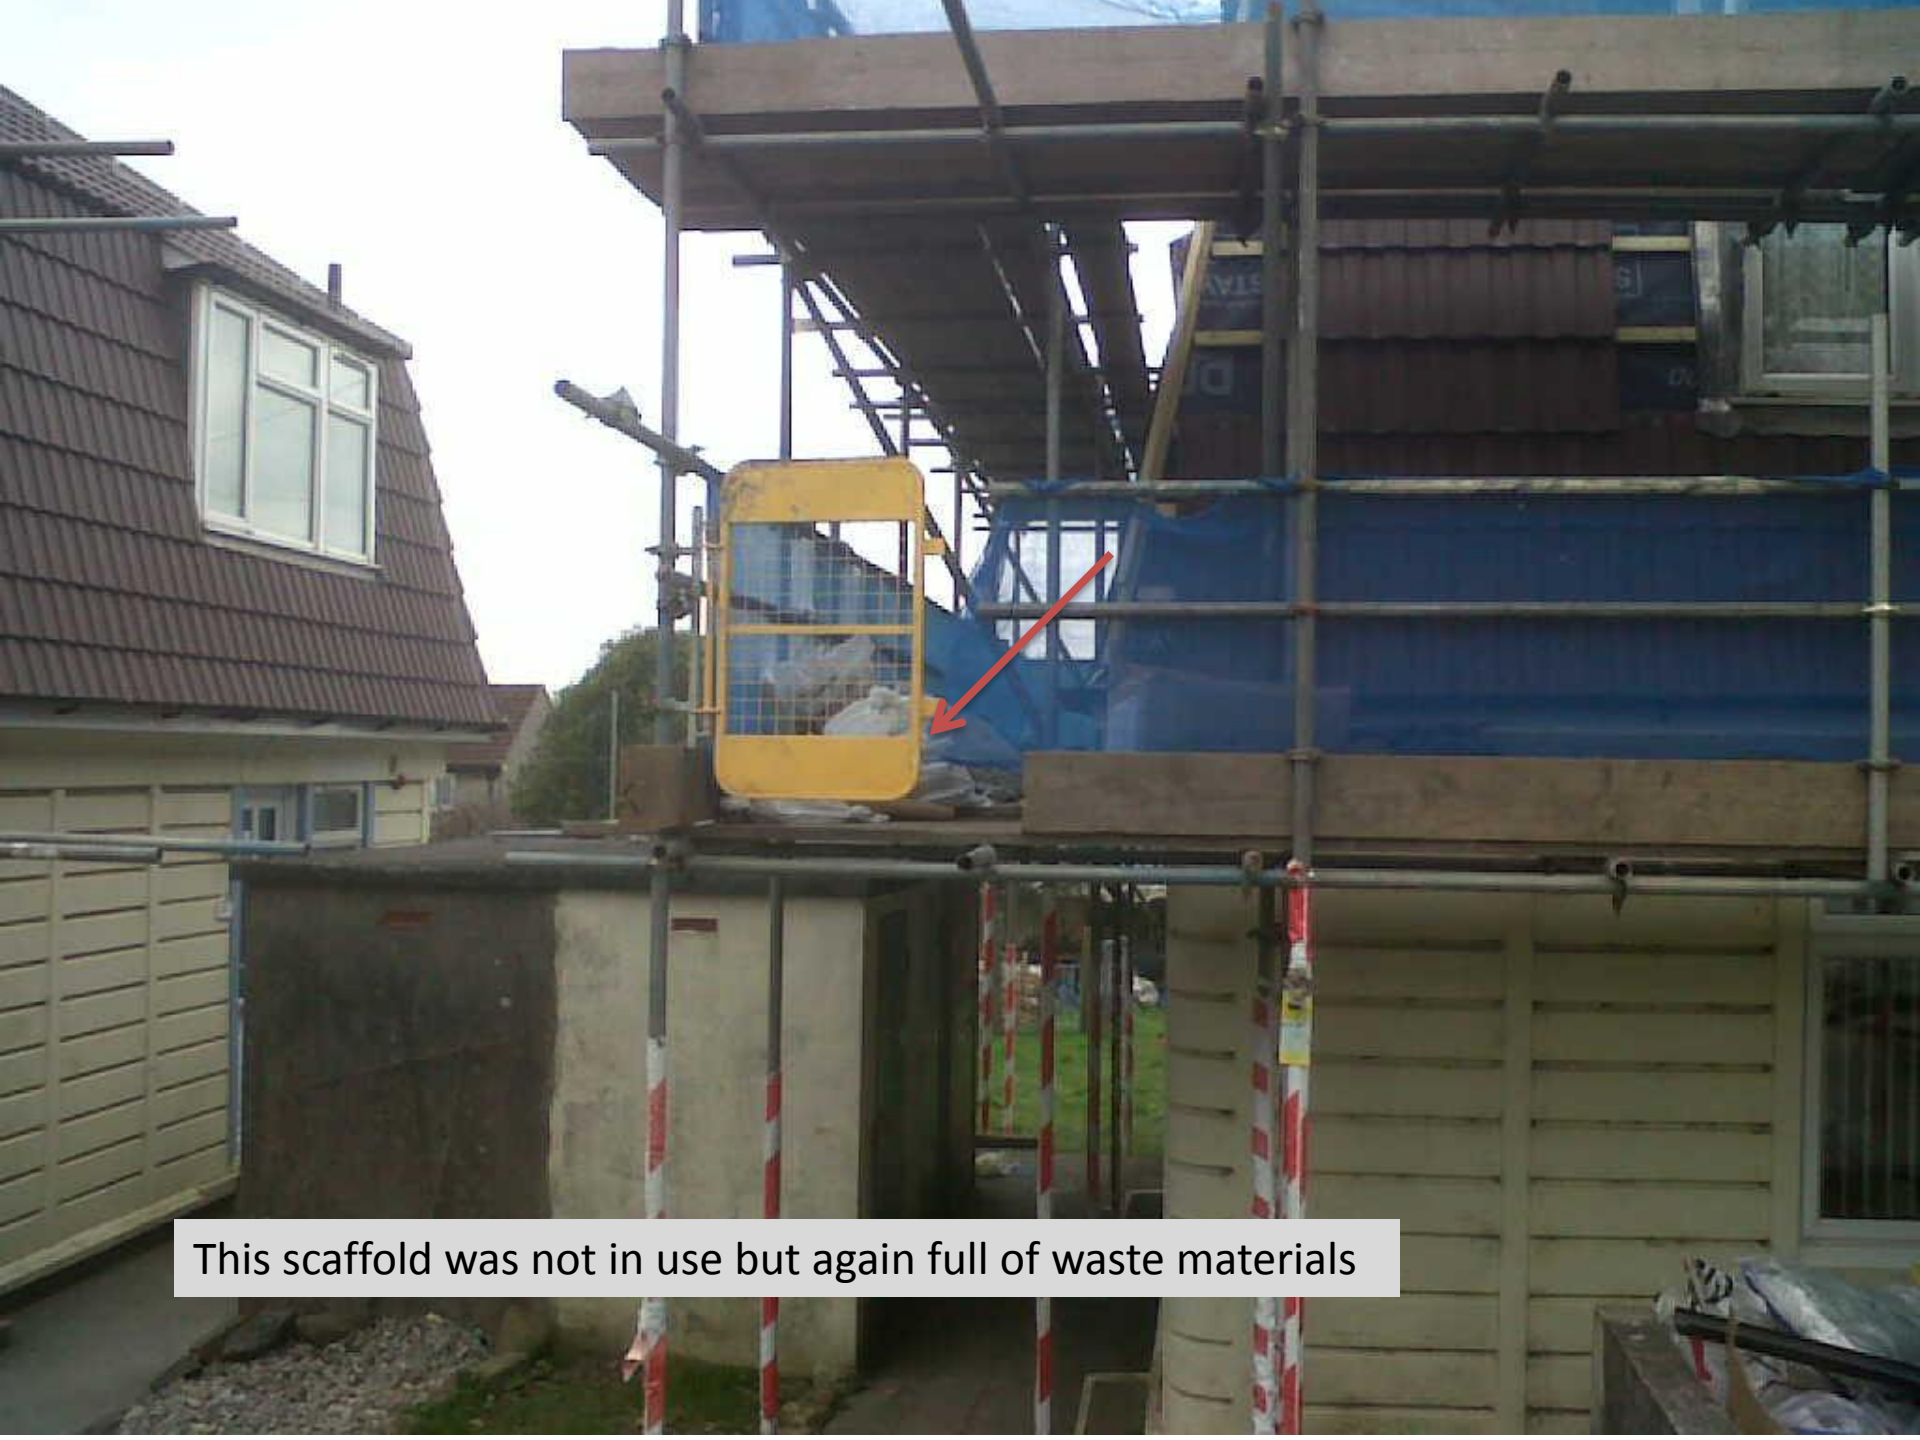
This scaffold was not in use but again full of waste materials
